Appendix A

Figures

Camp Hero Remedial Investigation
 Montauk, New York

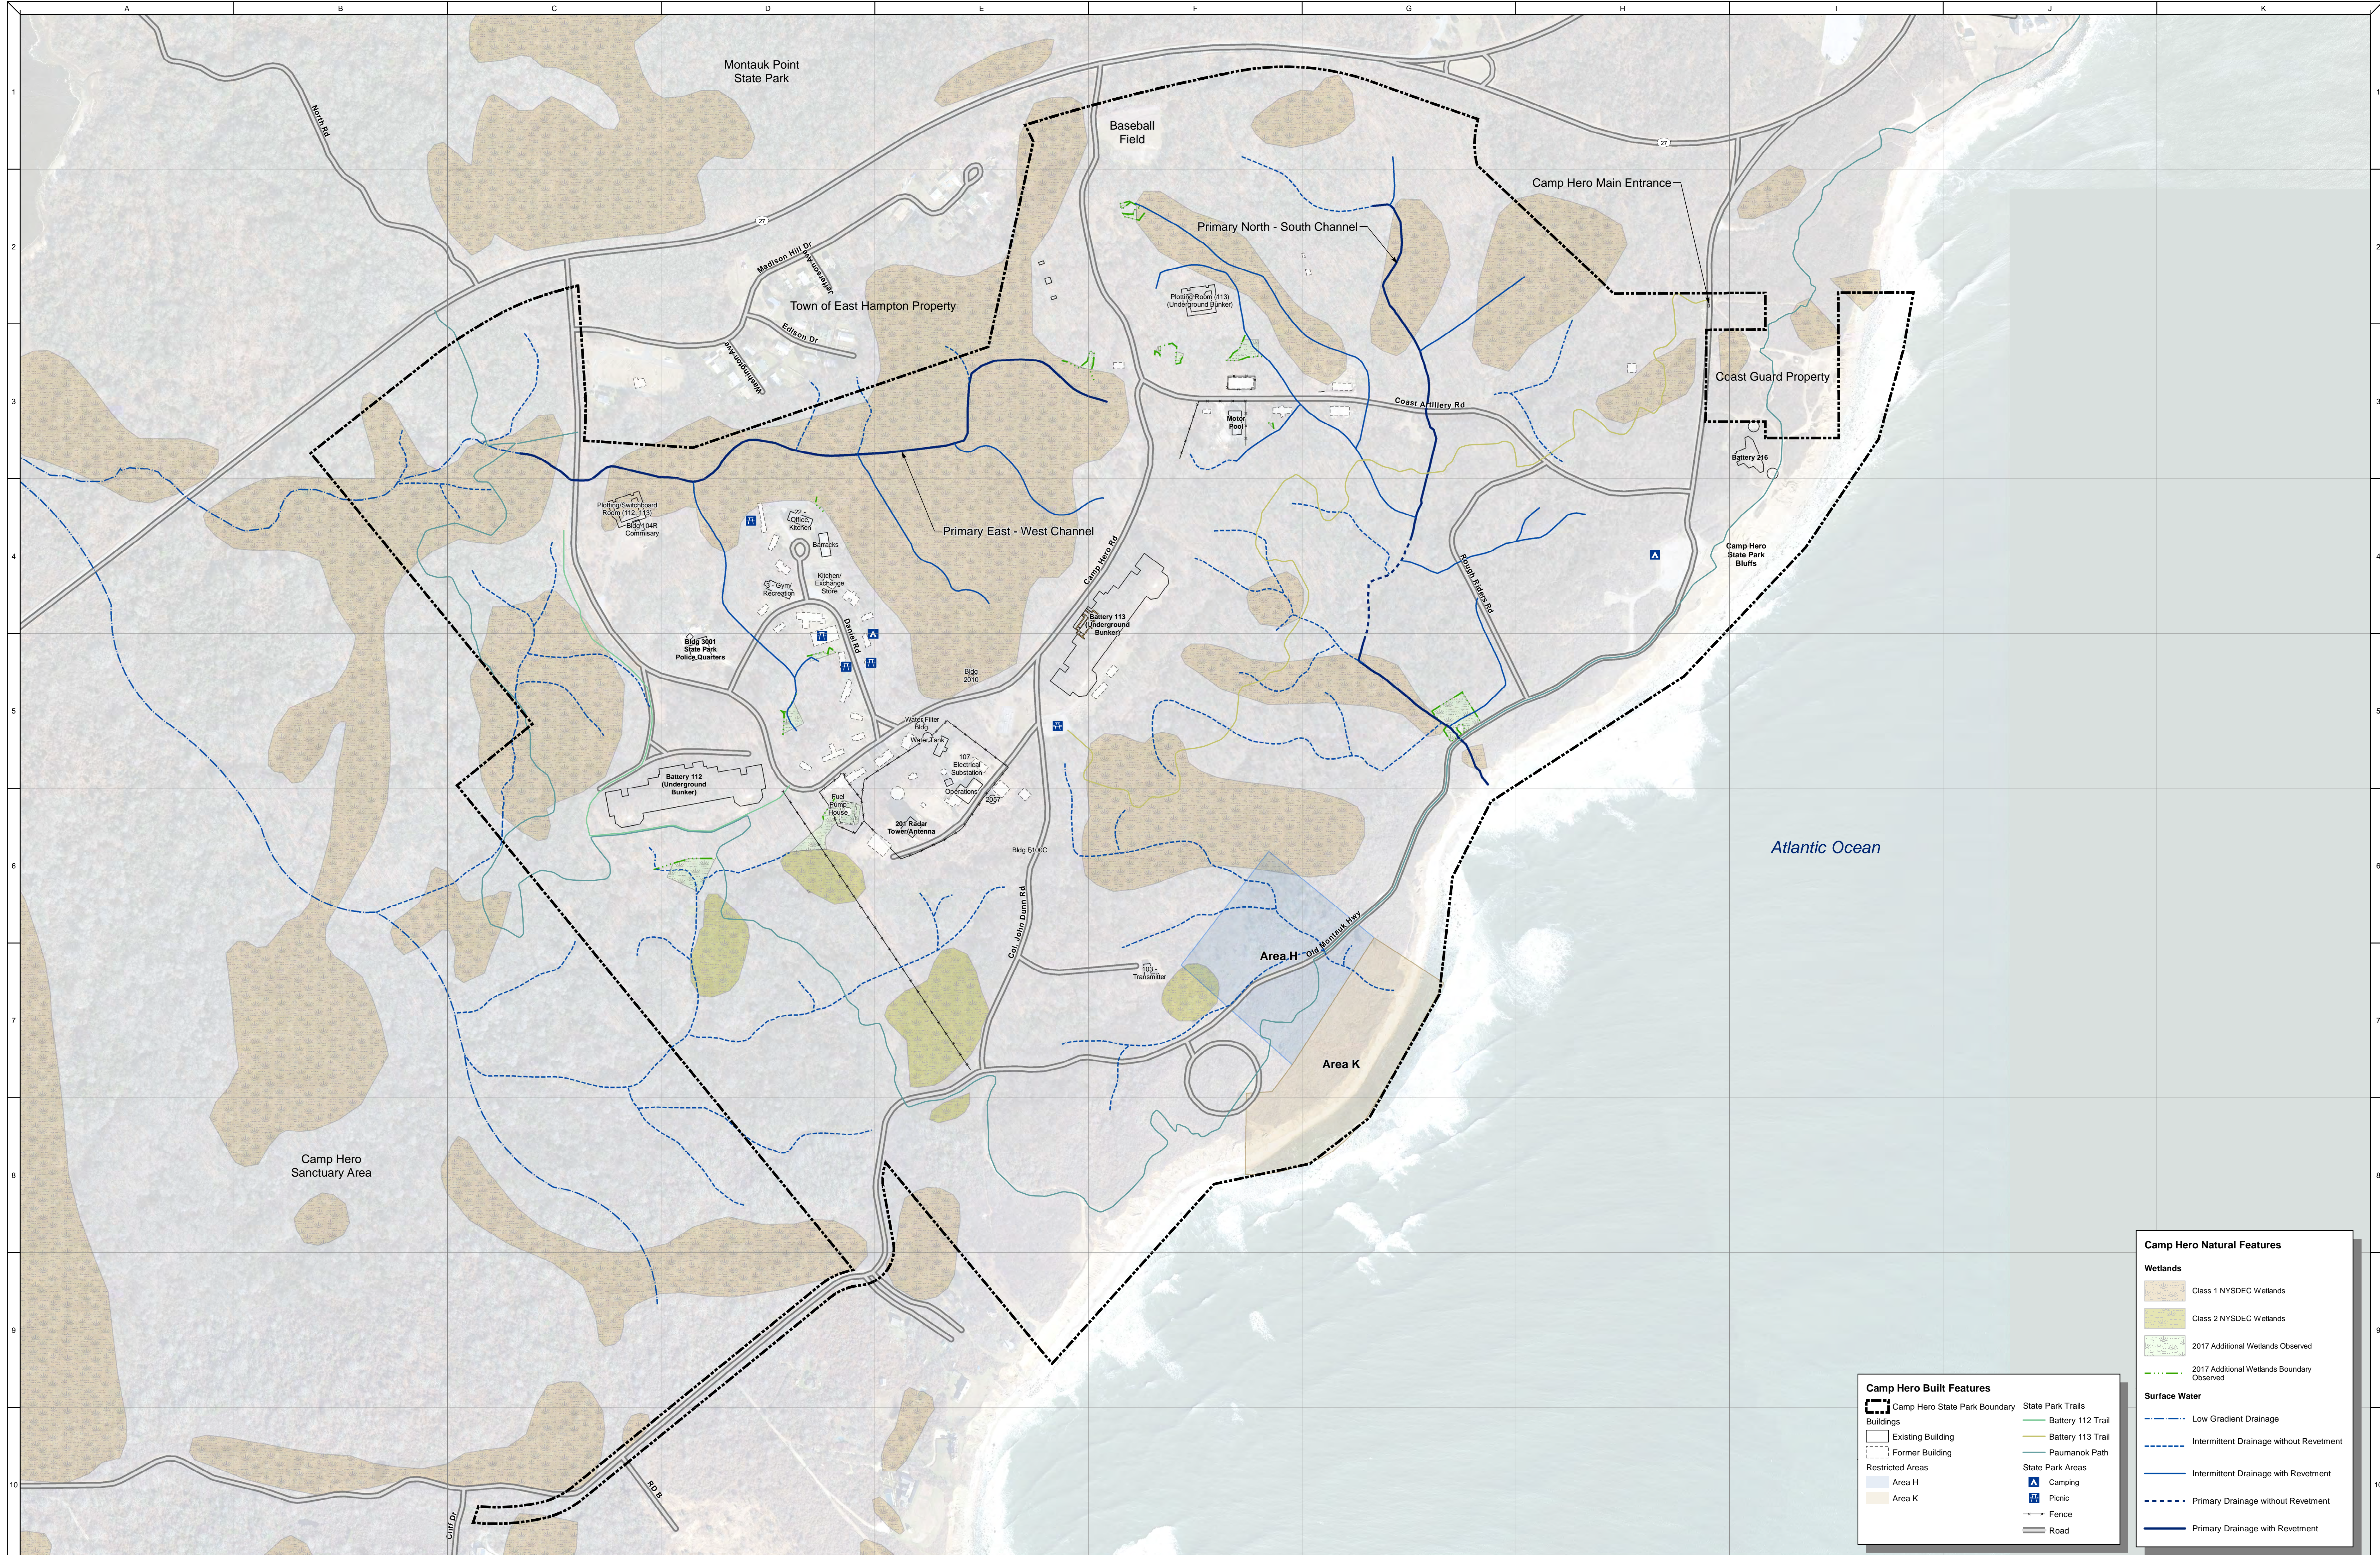
PROJECT NO: 60443903
 PREPARED BY: JS
 DATE: September 2018
Figure 1-2

Site Map
 Camp Hero Remedial Investigation
 Montauk, New York

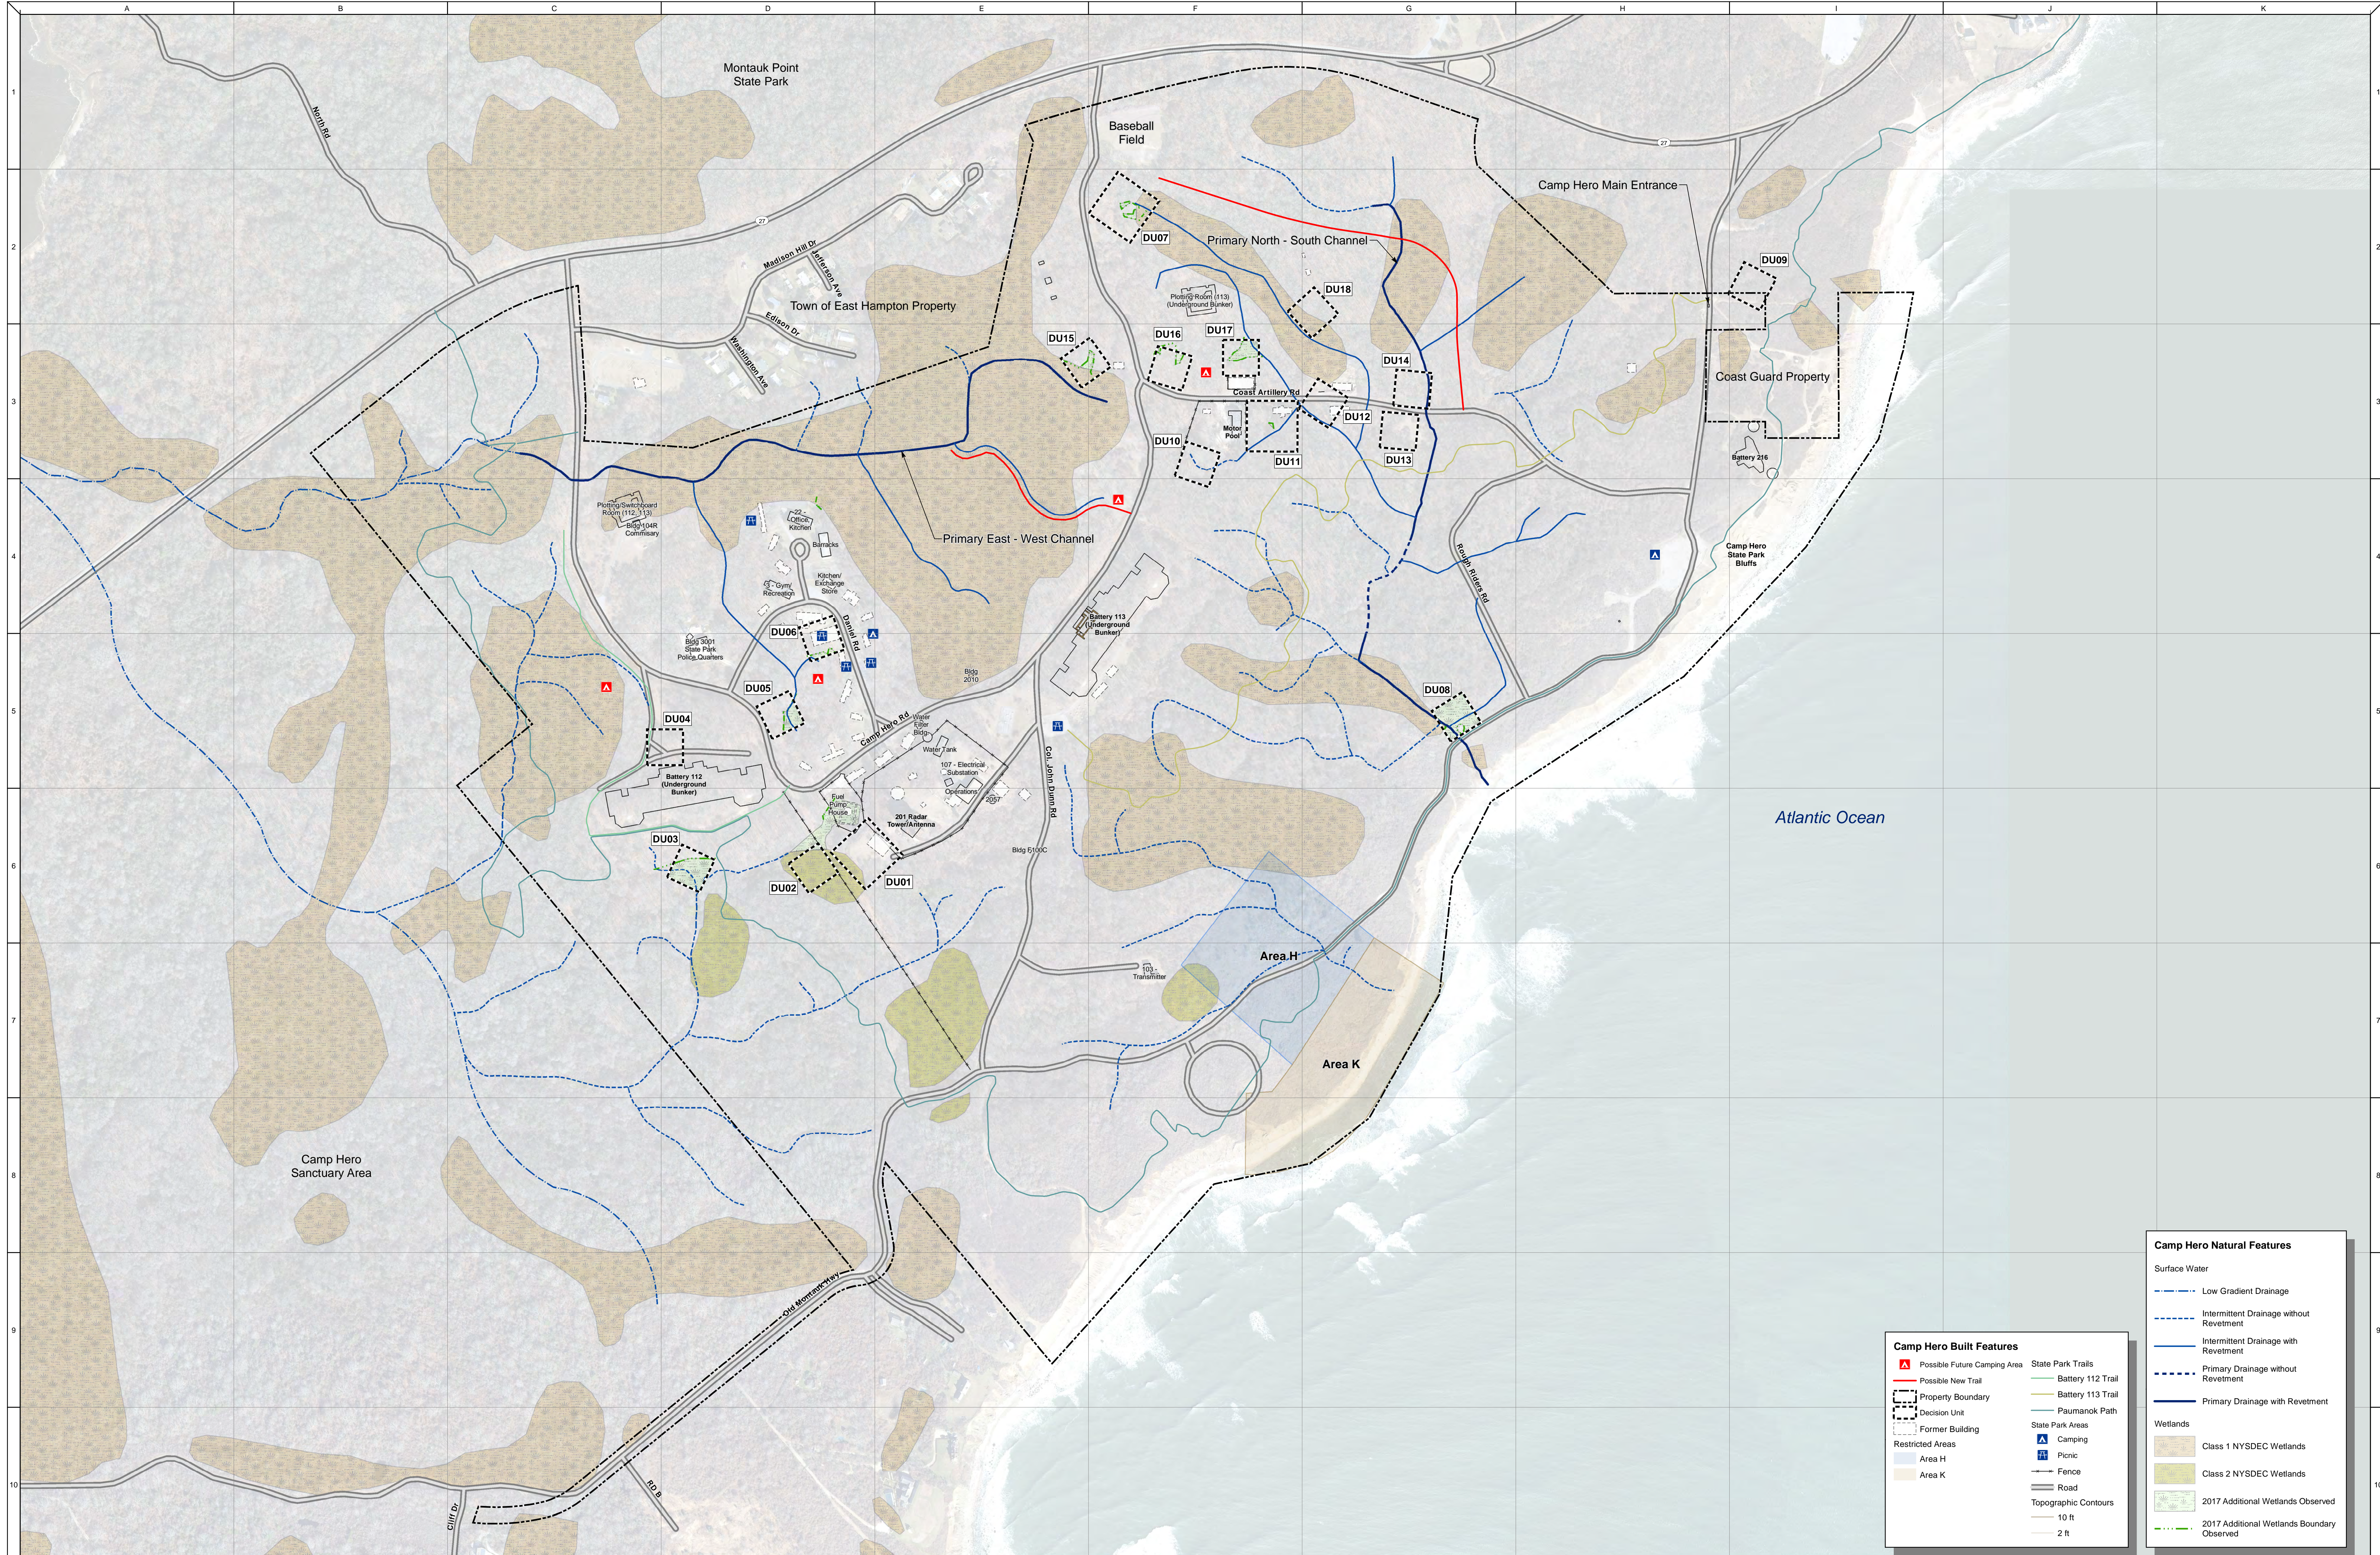
PROJECT NO: 60443903
 PREPARED BY: JS
 DATE: September 2018
 FIGURE: Figure 3-1

Current and Potential Future Land Use Map
 Camp Hero Remedial Investigation
 Montauk, New York

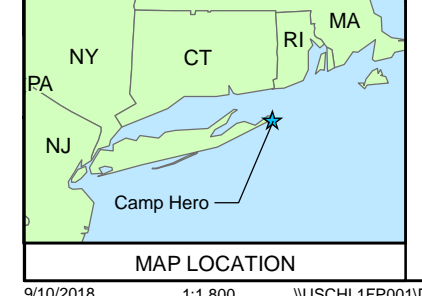
Figure 3-3

Perched Groundwater Elevation and Topographic Relief Map
 Camp Hero Remedial Investigation
 Montauk, New York

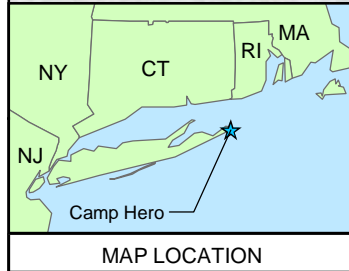
- Site Groundwater Monitoring Well
- Background Groundwater Monitoring Well
- Camp Hero State Park Boundary
- Existing Building
- Former Building

AECOM		3101 Wilson Blvd., Suite 900 Arlington, VA 22201 T 703-682-4900 F 703-682-4901	
		Groundwater Monitoring Well Network	
Camp Hero Remedial Investigation Montauk, New York			
PROJECT NO. 60443903	PREPARED BY: JB	DATE: September 2018	Figure 3-4

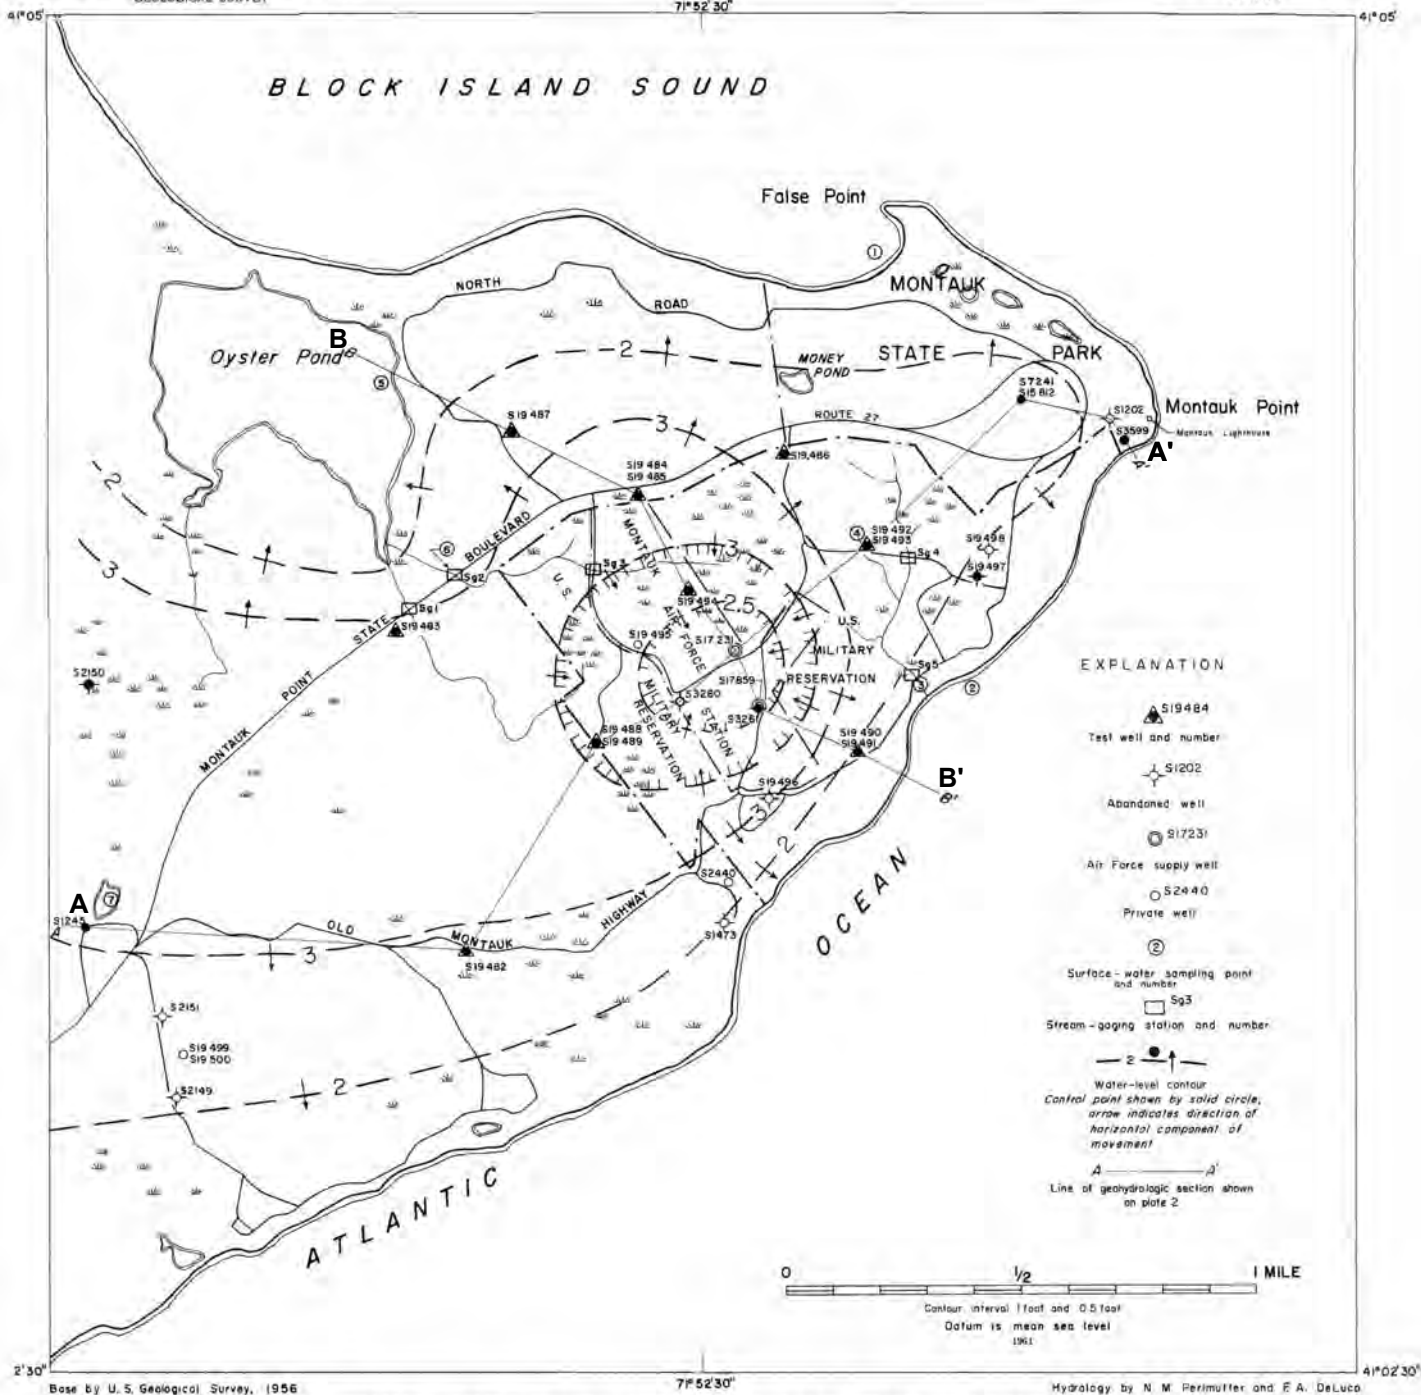
PROJECT NO. 60443903	PREPARED BY: ACC	DATE: April 2018	Figure 3-5
-------------------------	---------------------	---------------------	-------------------

- EXPLANATION**
- S19484
Test well and number
 - S1202
Abandoned well
 - S1723
Air Force supply well
 - S2440
Private well
 - 2
Surface-water sampling point and number
 - Sg3
Stream-gaging station and number
 - 2
Water-level contour
Control point shown by solid circle,
arrow indicates direction of
horizontal component of
movement
 - A-A'
Line of geohydrologic section shown
on plate 2

Base by U.S. Geological Survey, 1956

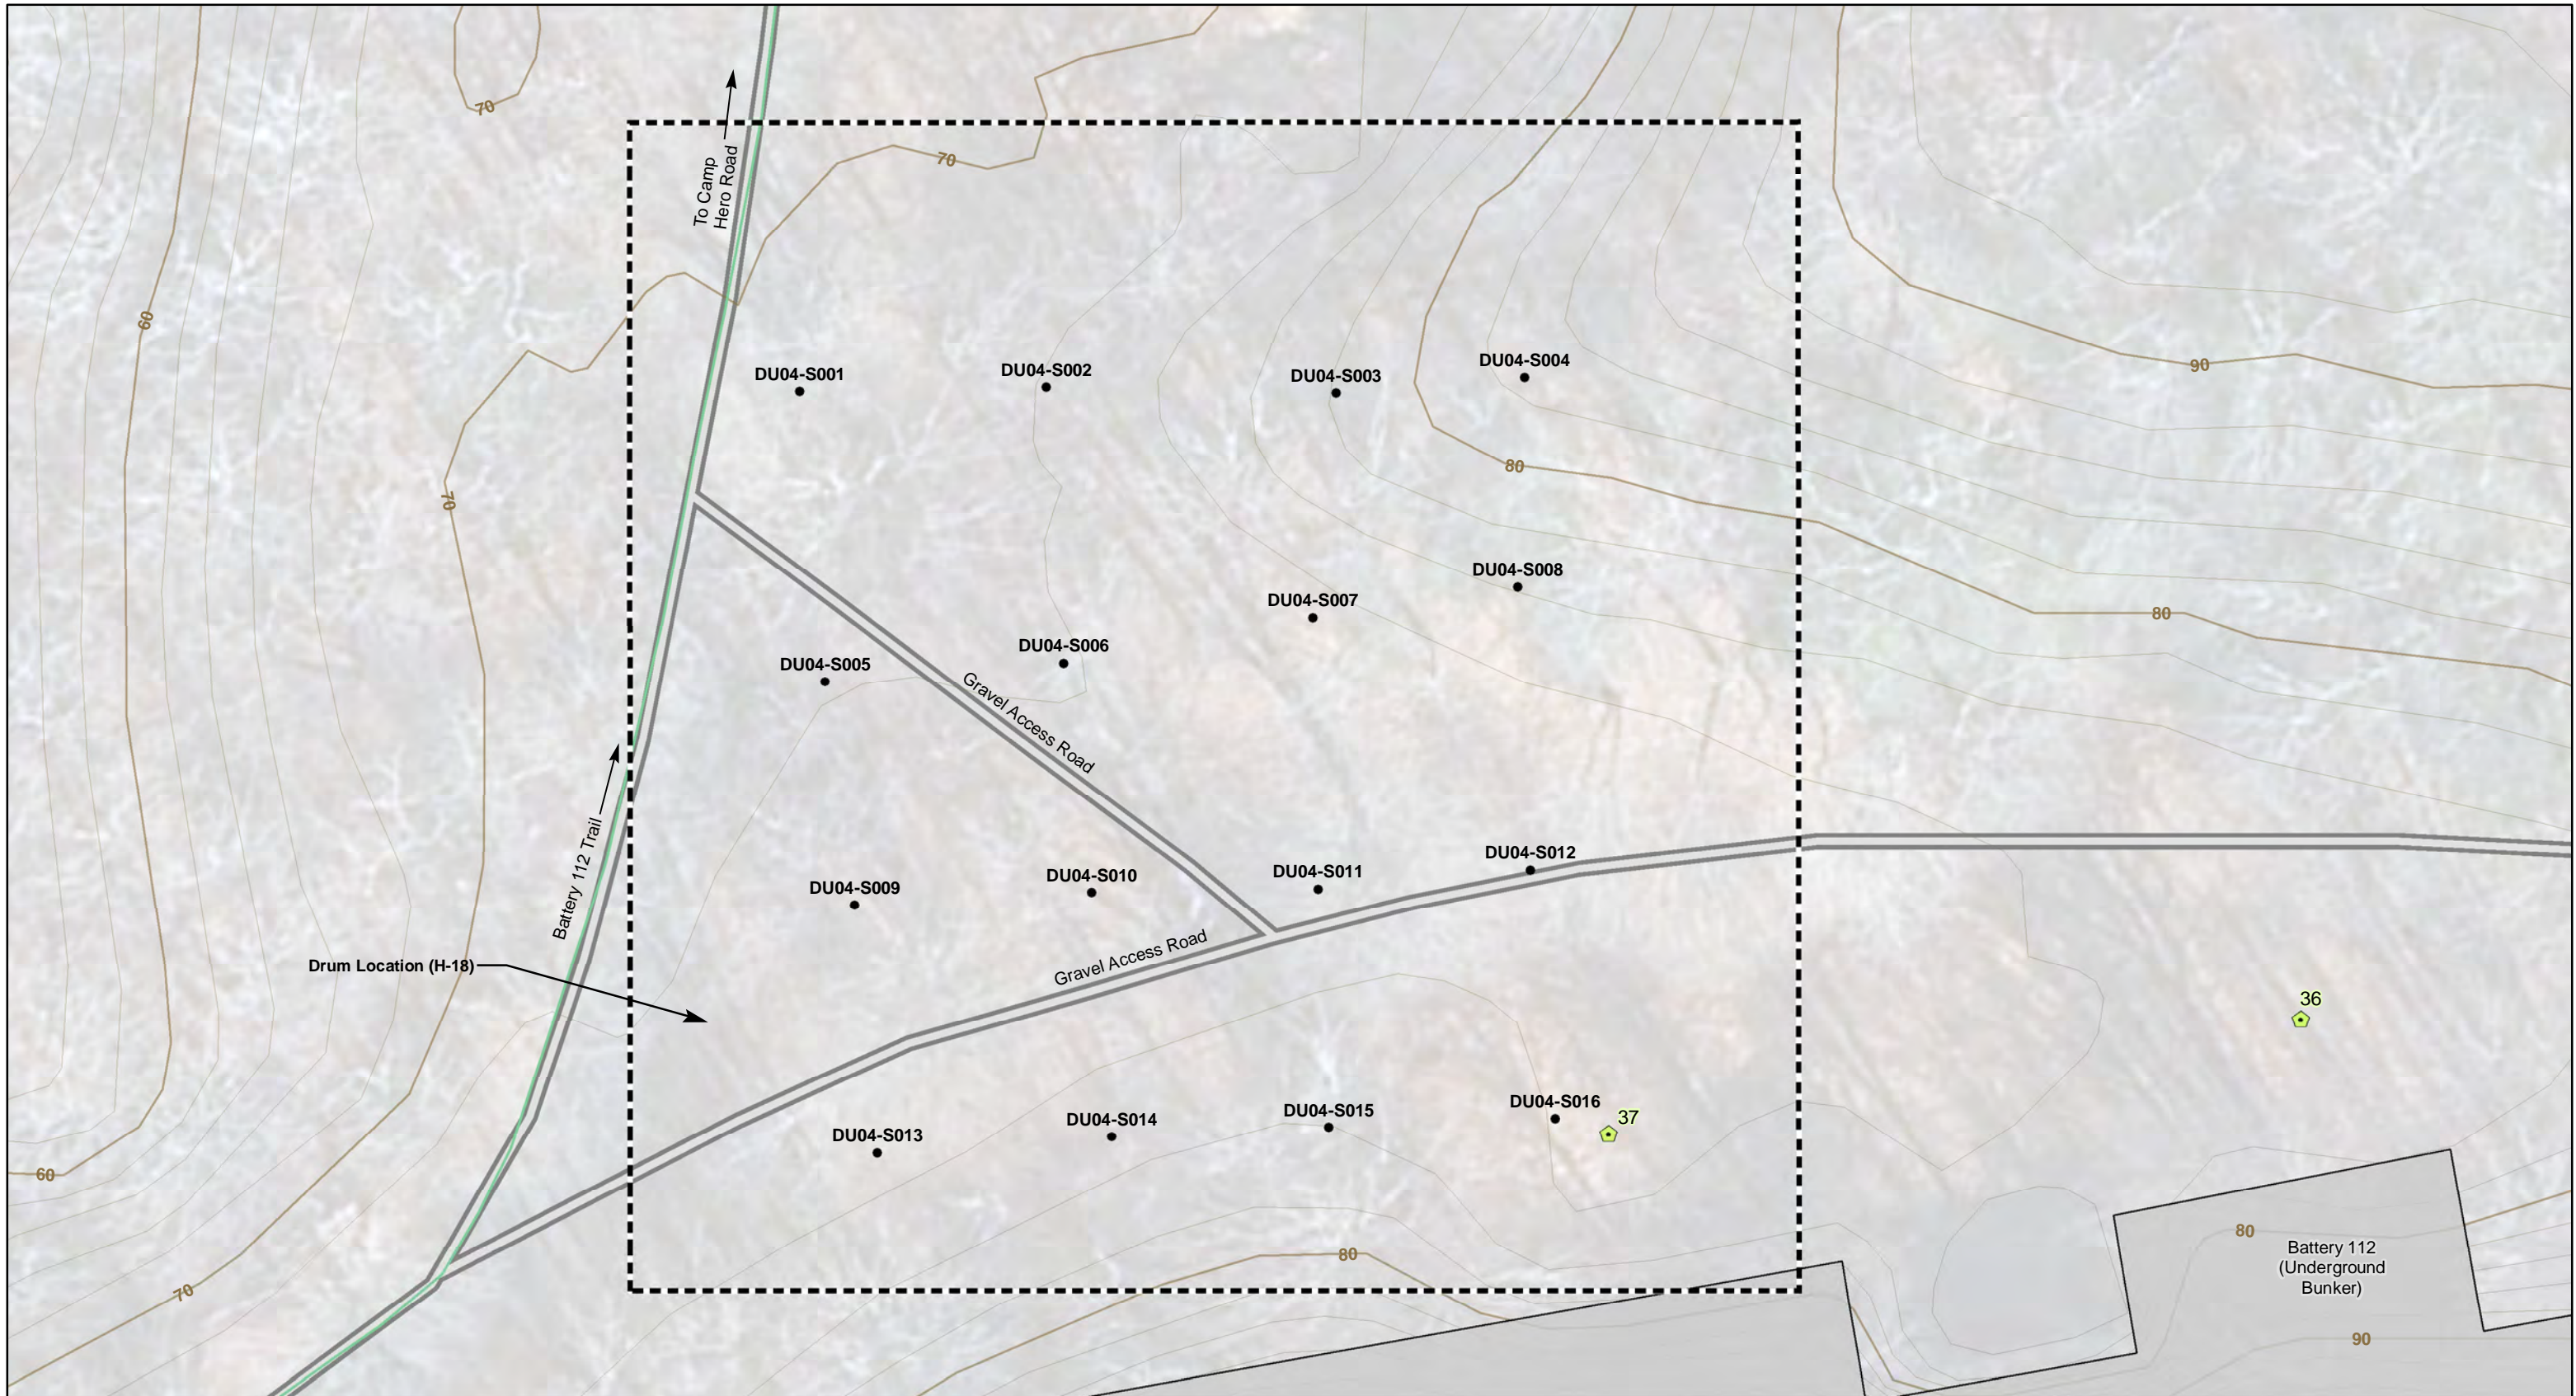
AECOM		3101 Wilson Blvd., Suite 900 Arlington, VA 22201 T 703-682-4900 F 703-682-4901	
RI Sampling Locations DU04, H18 Drum Area			
Camp Hero Remedial Investigation Montauk, New York			
PROJECT NO. 60443903	PREPARED BY: JB	DATE: July 2018	Figure 4-4a

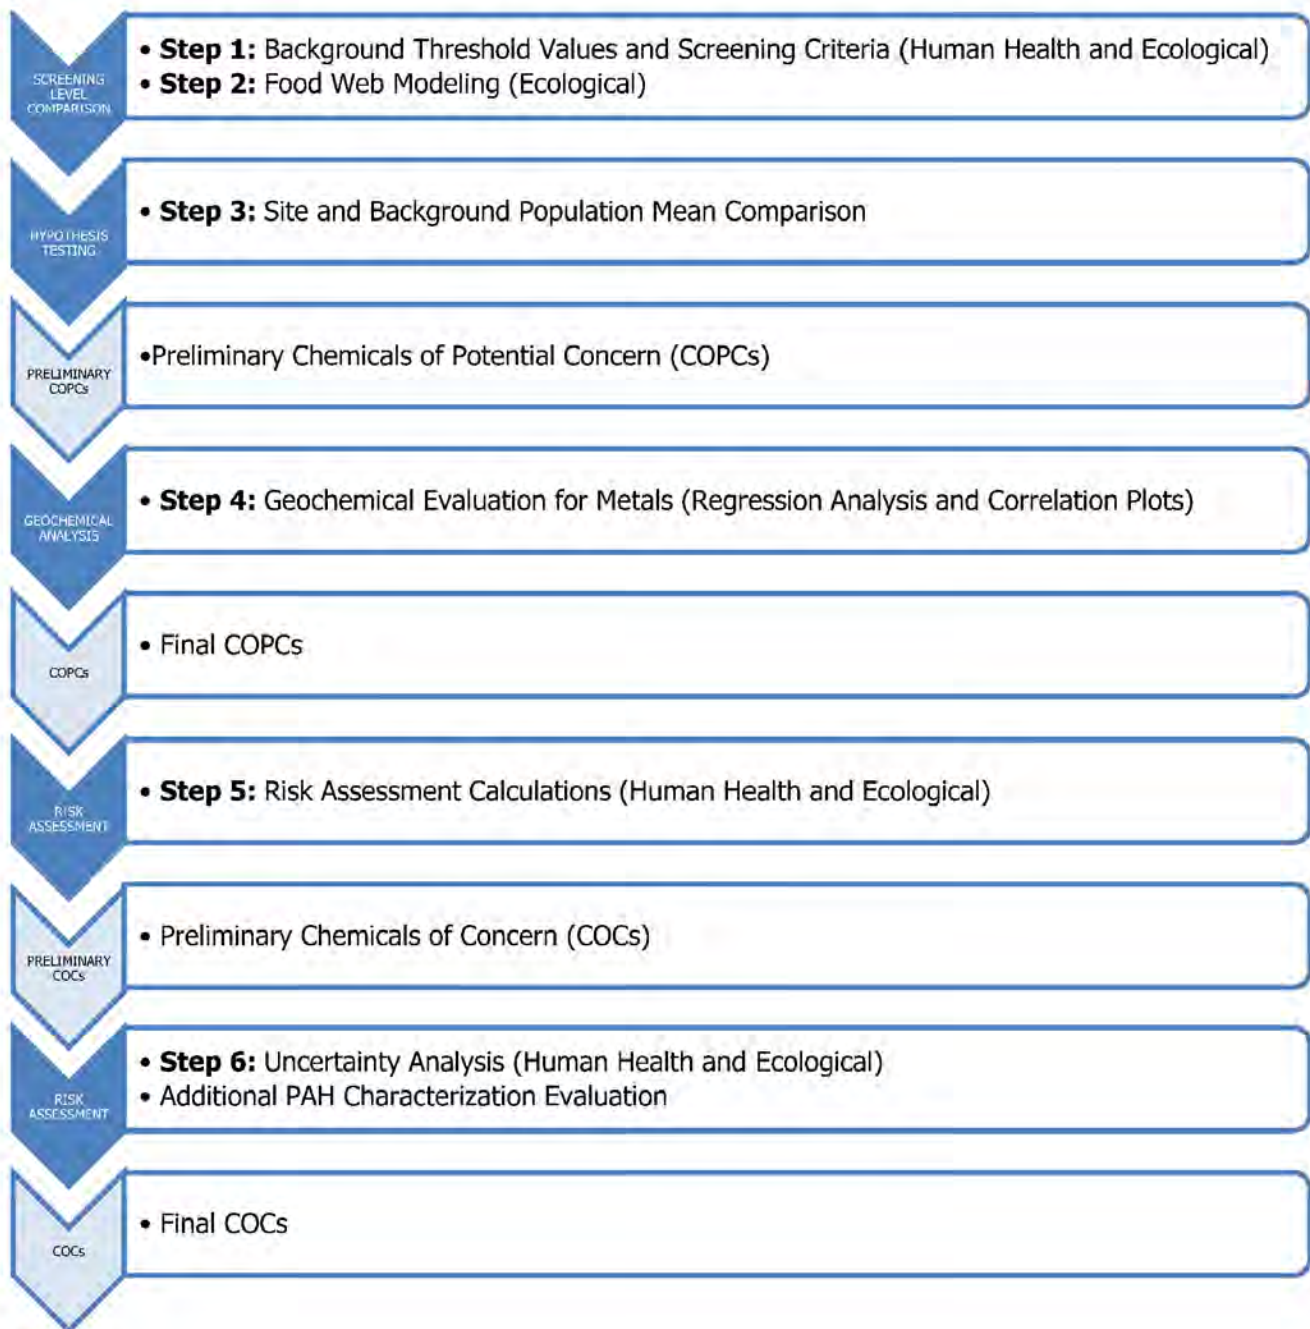
AECOM		3101 Wilson Blvd., Suite 900 Arlington, VA 22201 T 703-682-4900 F 703-682-4901	
		Risk Assessment Process Flow Chart			
Camp Hero Remedial Investigation Montauk, New York					
PROJECT NO. 60443903	PREPARED BY: JB	DATE: October 2018	Figure 6-1
